# HERITAGE IMPACT ASSESSMENT

## METRO CORRIDOR- I AND II, AGRA

## **HERITAGE IMPACT ASSESSMENT (HIA): PROPOSED METRO CORRIDOR- I AND II AND THE HERITAGE RESOURCES OF AGRA INCLUDING THE TWO WORLD HERITAGE PROPERTY OF TAJ MAHAL AND AGRA FORT**

**Specific HIA focus:** Proposed Metro corridor- I Sikandara to Taj East Gate, Agra, Uttar Pradesh

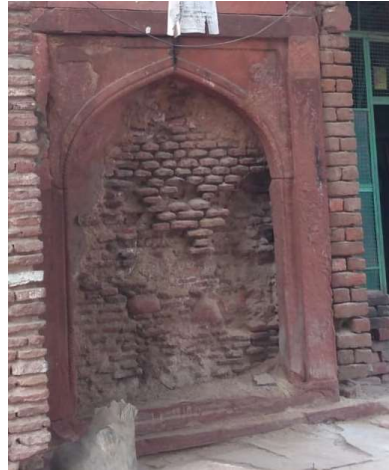
*The loose masonry and deteriorated stones of the exterior wall surface*

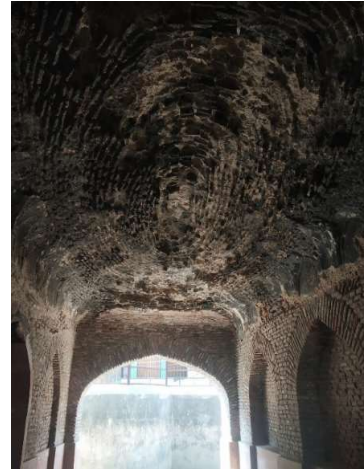
*Exposed ceiling masonry of platform of the tomb*

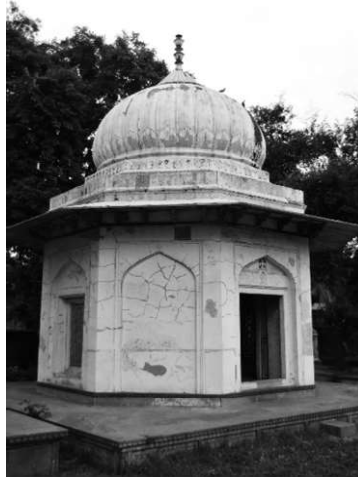
*Plaster cracks on exterior surface*

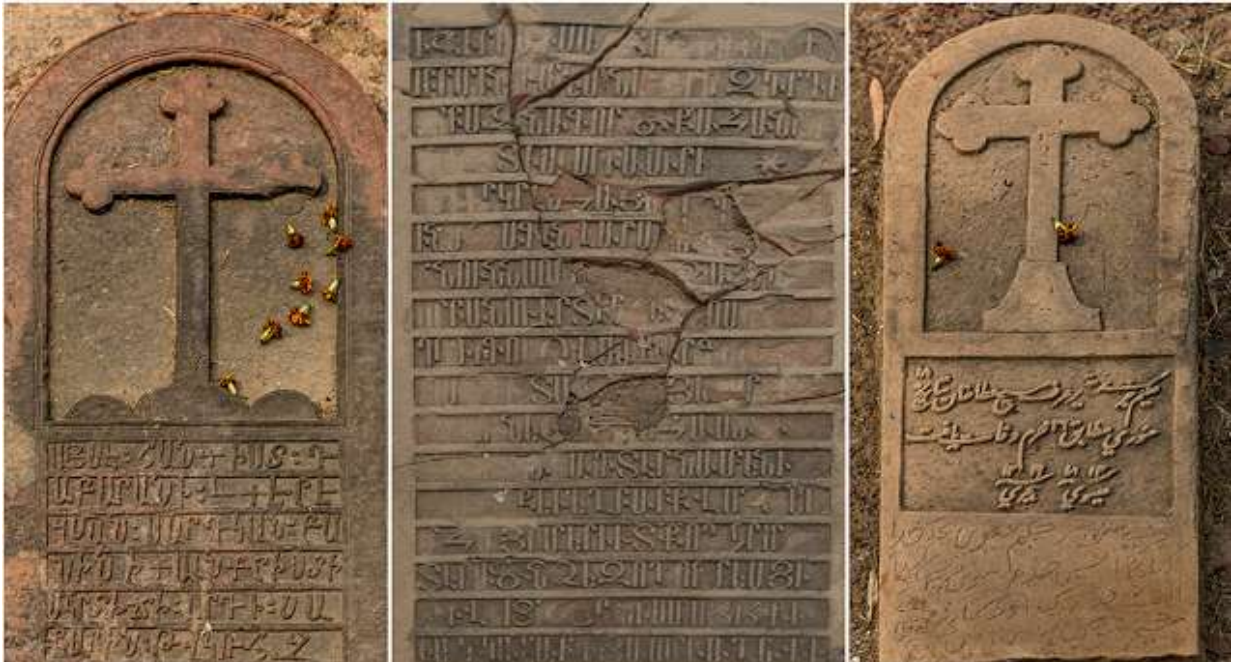
*Few of many inscriptions on the gravestones which are found all across the complex. Some of them are damaged.*

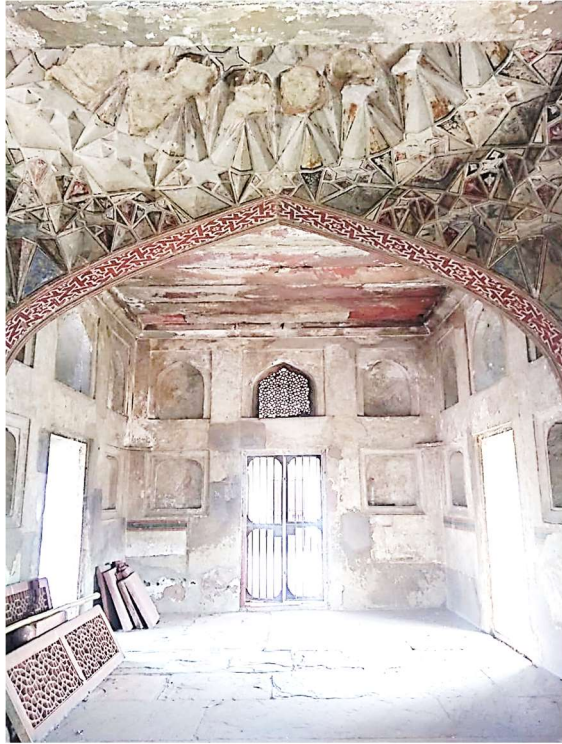
*Decorative features in the interiors of pavilions showing sign of deterioration*

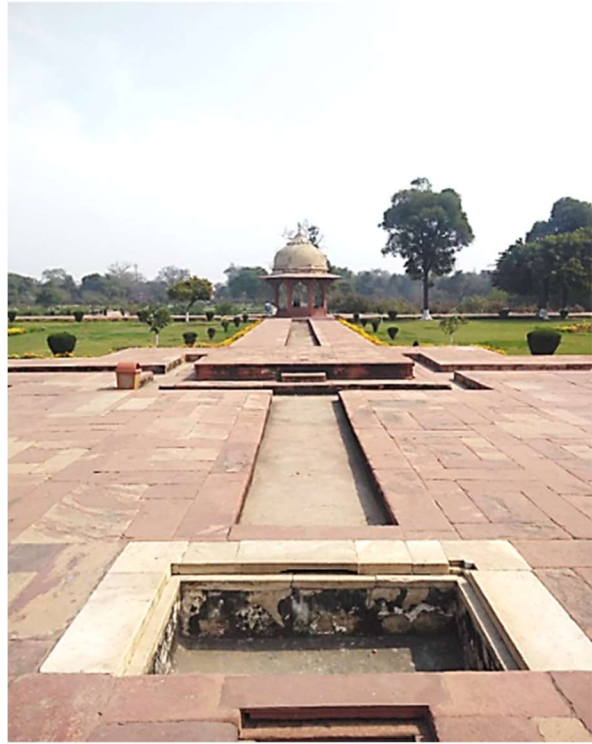
*Condition of terraces are stable. There are signs of stone deterioration in patches all over.*

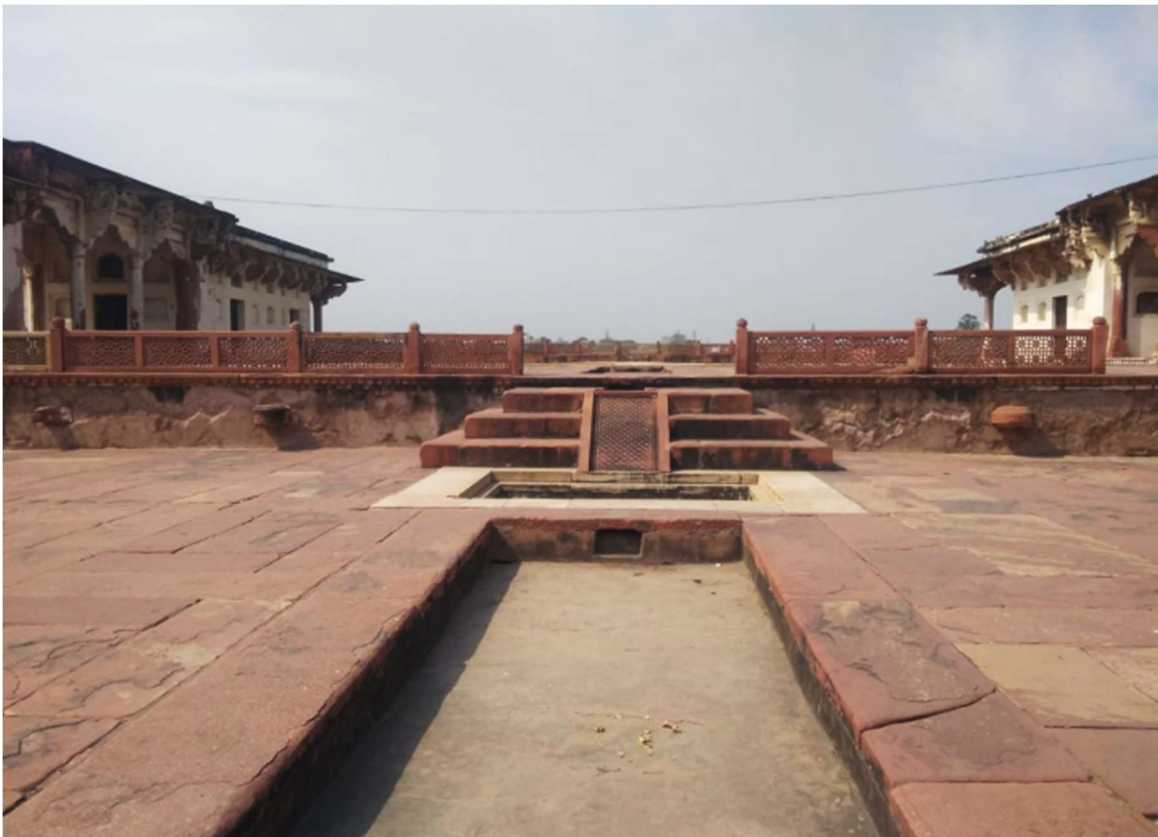
*Condition of terraces of charbagh are stable. Signal storey houses are also in stable condition. There are signs of stone deterioration.*

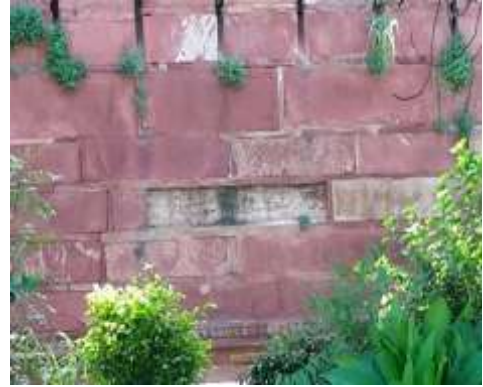
**Figure 23: Loss of Cladding**

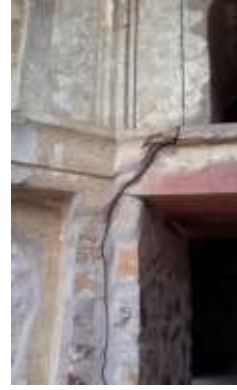
**Figure 25: Vertical Crack**

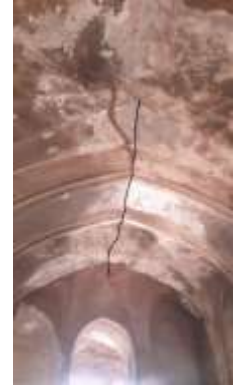
**Figure 26: Horizontal Crack**

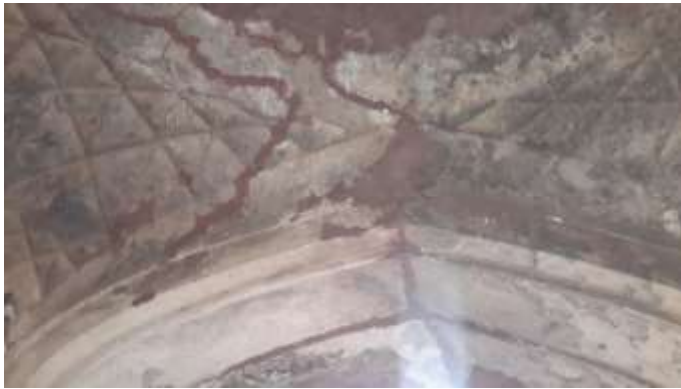
**Figure 27 Cracks in the ceiling**

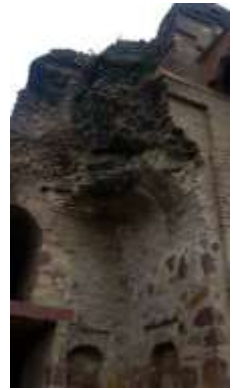
**Figure 28: Vegetation Growth and structural damage**

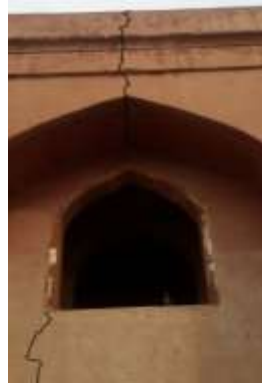
**Figure 30: Vertical Crack**

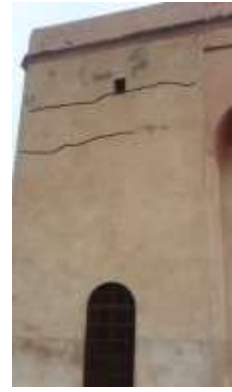
**Figure 31: horizontal crack**

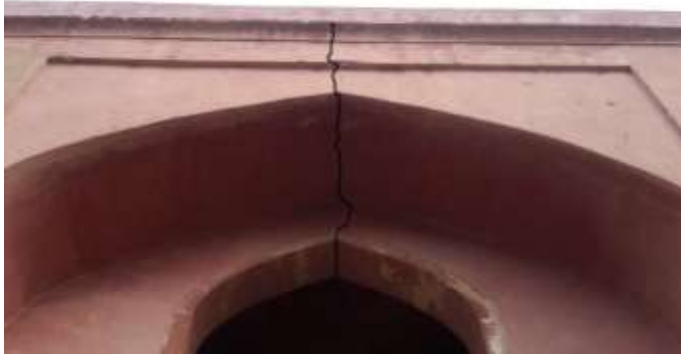
**Figure 32: Structural crack**

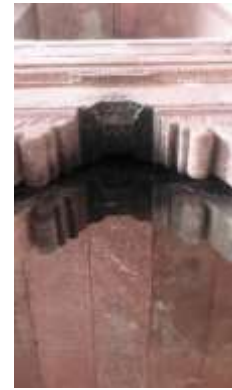
**Figure 33: Soot formation**

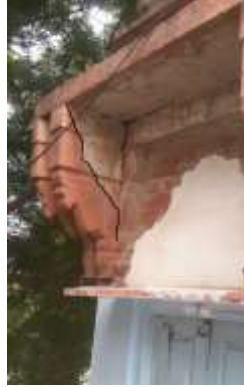
**Figure 38: Structural Crack**

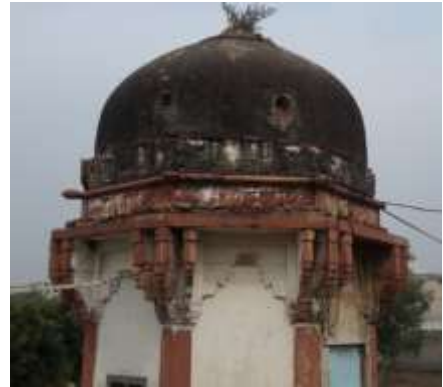
**Figure 39: Vegetation Growth**

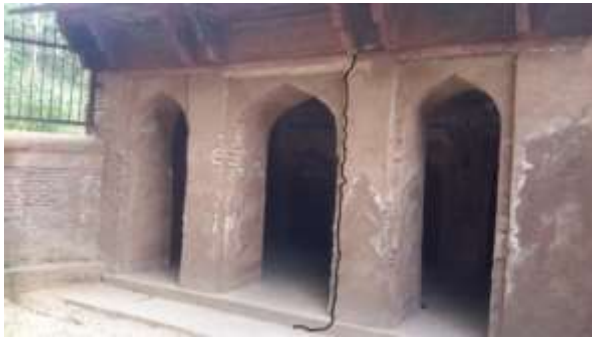
**Figure 41: Vertical cracks**

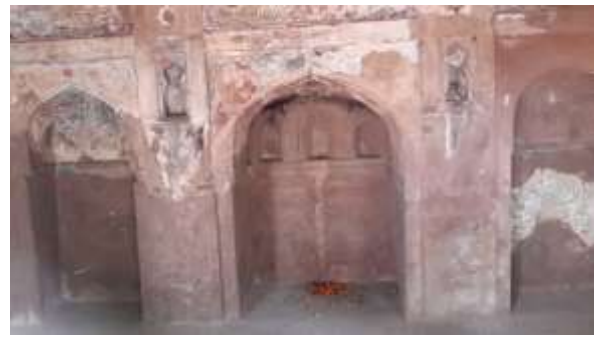
**Figure 42: Plaster Delamination**

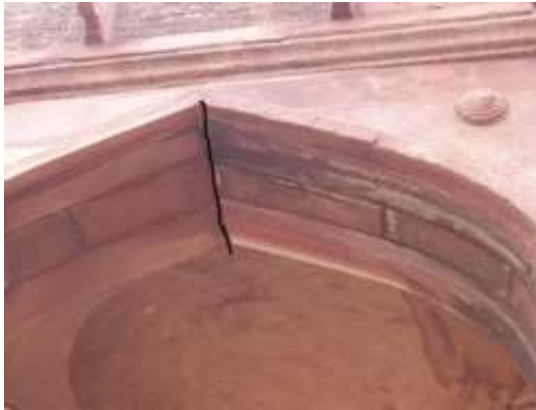
**Figure 46: Structural Crack**

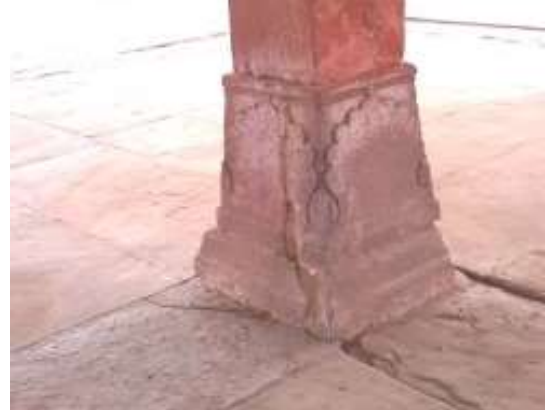
**Figure 47: Wind Erosion**

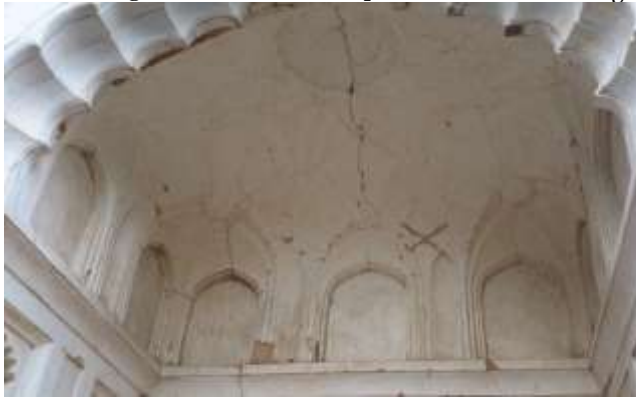
**Figure 51: Structural Crack**

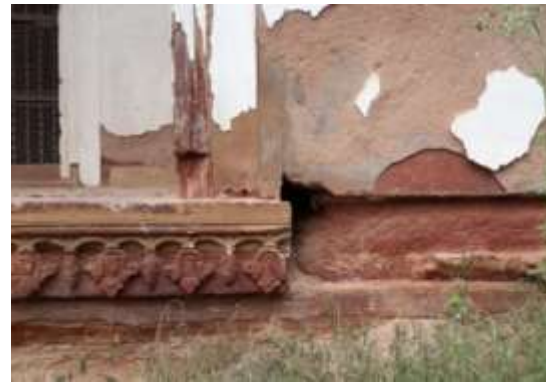
**Figure 52: Openings at Base**

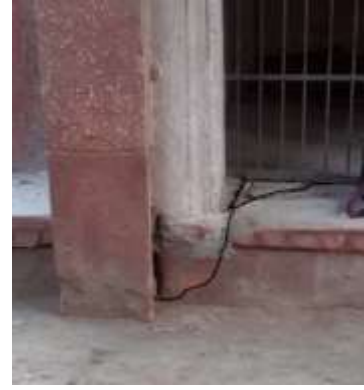
**Figure 56: Horizontal Crack**

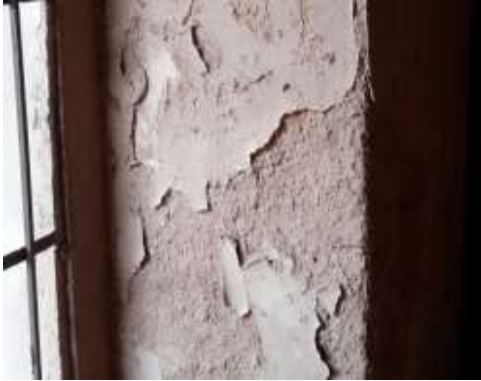
**Figure 57: Plaster removal**
