# HERITAGE IMPACT ASSESSMENT

## METRO CORRIDOR- I AND II, AGRA

## **HERITAGE IMPACT ASSESSMENT (HIA): PROPOSED METRO CORRIDOR- I AND II AND THE HERITAGE RESOURCES OF AGRA INCLUDING THE TWO WORLD HERITAGE PROPERTY OF TAJ MAHAL AND AGRA FORT**

**Specific HIA focus:** Proposed Metro corridor- I Sikandara to Taj East Gate, Agra, Uttar Pradesh

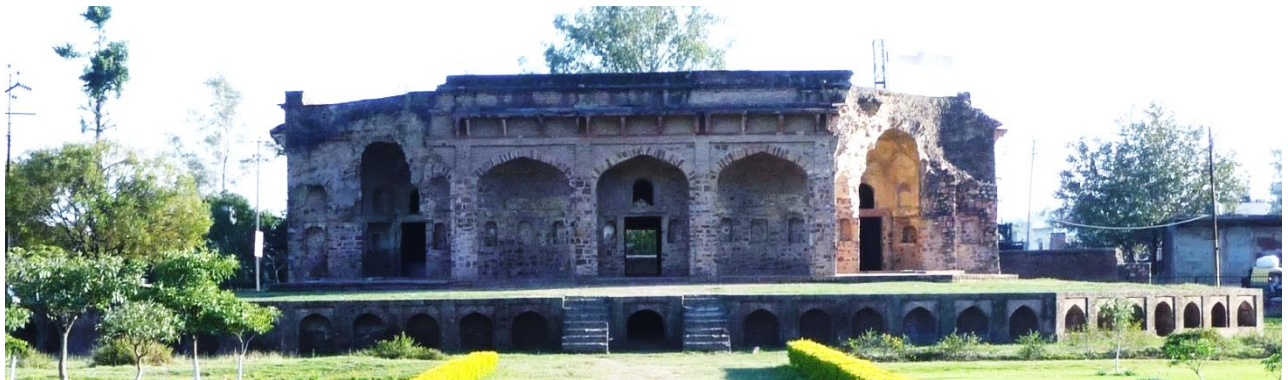
*Image 5.2.6 West view of Lodhi Tomb*

Lodhi's tomb Sikandara	<p>Several structural cracks have been observed in walls and ceiling.</p> <p>Tomb of Lodhi show signs of distress.</p> <p>Masonry loss at the edges of the external walls.</p> <p>The entry to cenotaph is blocked.</p> <p>Repair works are done with lakhori bricks.</p>	<p>Air pollution affecting the historic surfaces and loss of original setting contributed by:</p> <ul style="list-style-type: none"> <li>• Heavy vehicular traffic on NH 19</li> <li>• New construction works along the NH 19 as well as in the immediate surrounding</li> <li>• New flyover constructed on Bodla road immediately in front of West Gateway of Akbar's tomb at a distance of approx. 350 mts.</li> <li>• Platform of the tomb is partially missing owing to extension of the present road.</li> </ul>
	Kanch Mahal, Sikandara	<p>Kanch Mahal is structurally stable and have no severe sign of structural dilapidation</p> <p>Kanch Mahal also shows structural crack in column.</p> <p>Stone surfaces are showing sign of deterioration at different places which mainly includes delamination of the cladding stones.</p> <p>Mughal glazed works over the domes of the jharokhas are partially missing but complete pattern can be identified out from the profile.</p>	<p>Air pollution affecting the historic surfaces of the Kanch Mahal which has intricate stone carving and glazed tile works.</p> <ul style="list-style-type: none"> <li>• Heavy vehicular traffic on NH 19 running along the edge of the monument.</li> <li>• New construction works along the NH 19 as well as in the immediate surroundings.</li> <li>• New flyover constructed on Bodla road immediately just in front of West Gateway of Akbar's tomb at a distance of approx. 265 mts.</li> </ul>

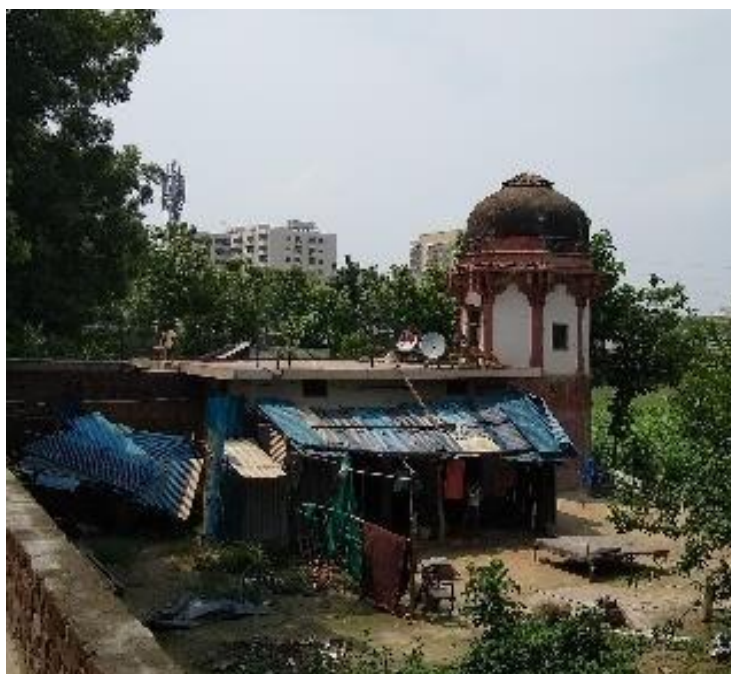
*Image.5.2.7 View of one of eight chattri's of Guru Ka Taal*

4	Guru Ka Taal	<p>There is no water in the Guru Ka Taal.</p> <p>The eight chhatris show major distress signs and some of their architectural members are now missing.</p> <p>Most of the retaining wall and ghats are decayed, partly missing and not visible.</p> <p>Decrease in the larger catchment area of Taal because of urban development.</p> <p>The leftover fertile land of</p>	<p>Guru Ka Taal is not approachable from the NH 19.</p> <p>New Gurudwara buildings are constructed around the Taal and has blocked the visibility and connectivity from the NH 19.</p> <p>New construction over the retaining walls and ghats of the Taal.</p> <p>Few chattries are encroached and people are living there.</p>

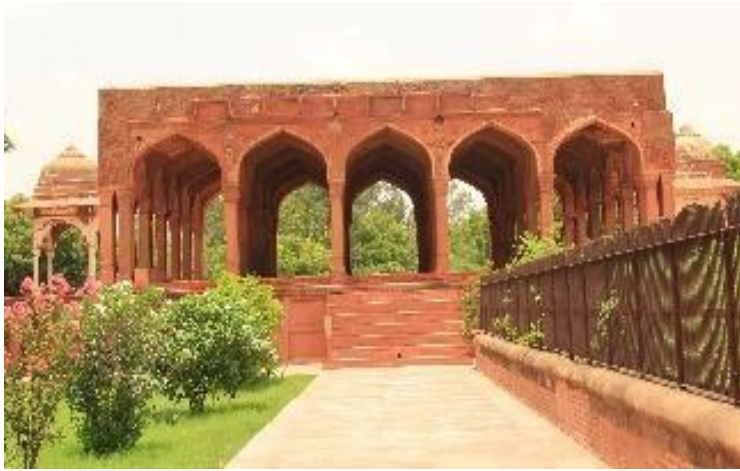
*Image 5.2.10 External view from of Tomb of Salabat Khan from westward direction*

6.1	Tomb of Salabat Khan	<p>Stone members are eroded due to wind resulting rounding of the stone columns at the base. It has affected many structural members severely where it has lost significant depth of the member.</p> <p>Cracks in the ceiling were also observed.</p>	<p>The original entry of the monument is now lost and is now approachable through a 2.5 mtr wide passage which has marble house on one side and new construction on other side.</p> <p>Severe water logging during rainy season adversely affects entry to the monument.</p>

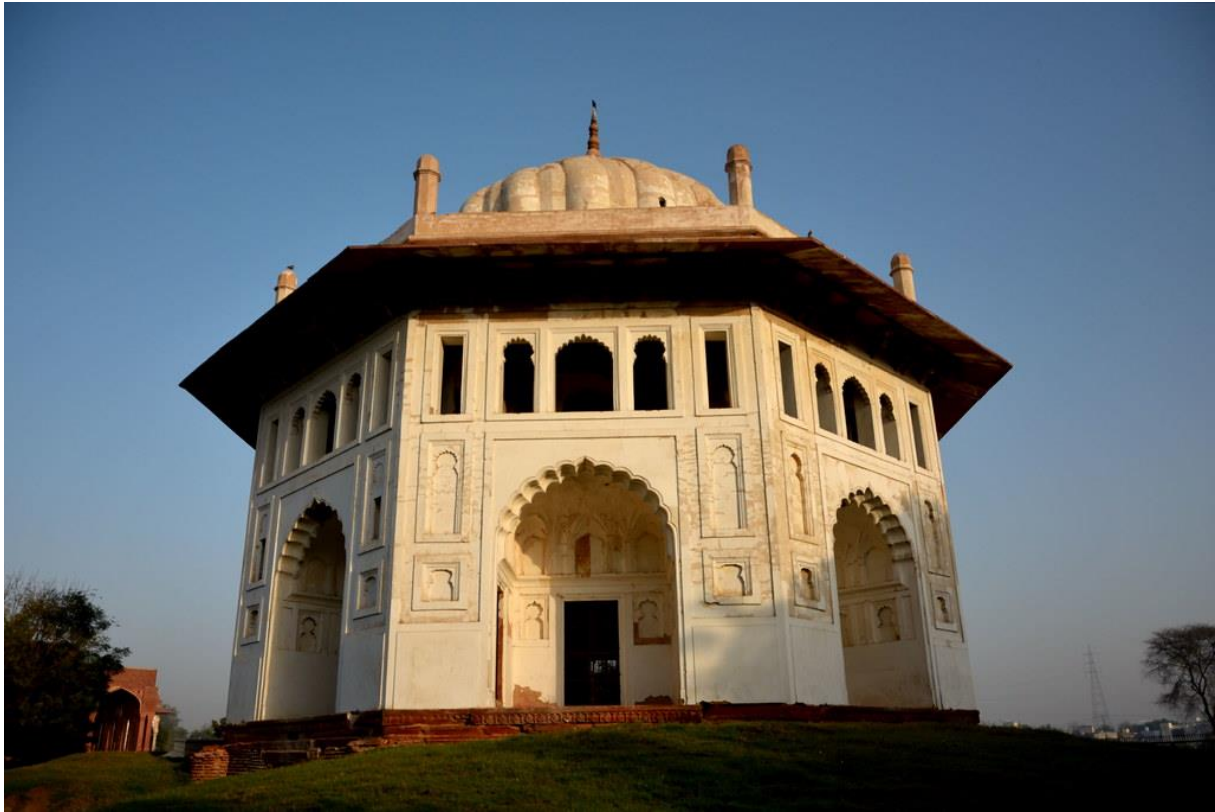
*Image 5.2.11 Image showing external view of Sadiq Khan*

6.2	Tomb of Sadiq Khan	<p>The Tall structure stands on a mound.</p> <p>Repair works to the structure were in process during surveys.</p> <p>Several cracks were observed in the engrailed arches and exterior surfaces.</p>	<p>The original setting of the complex is lost and most of the open area in the front is now used for commercial purpose.</p>
7	Barah Khamba	The main structure of Barah Khambha is in stable condition.	<p>The monument has lost its original context and is now surrounded by several new buildings.</p> <p>The monument has lost its original entry and is now approachable through narrow lanes.</p>
8	Old Delhi Gate of City	<p>Blackening and other deposits are visible on the internal surfaces of the gate.</p> <p>The Gate shows no severe sign of structural damage and material deterioration.</p>	<p>The gateway has lost its original context and stands in isolation enclosed by a boundary wall in close proximity to Raja Ki Mandi railway station.</p> <p>Railway station is just 25 mtrs away from the monument.</p> <p>The vehicular traffic previously used to pass through the gateway which has now been diverted outside the gate (date is unknown).</p>

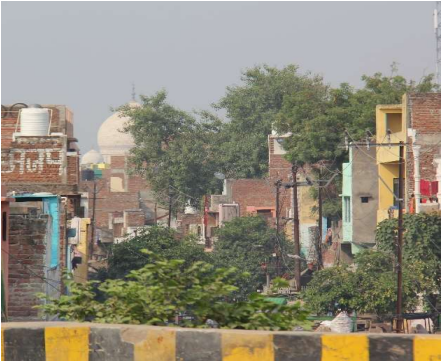
<p>Viewpoint locations were established through Research identified 16 viewpoints of Taj (TMV1, TMV2, TMV3, TMV4, TMV5, TMV6, TMV7, TMV8, TMV9, TMV10, TMV11, TMV12, TMV13, TMV14, TMV15, TMV16) which is then verified through fieldwork. (View from Fatehabad road at Taj ganj, looking North of the site ) one viewpoint (TMV17) was identified on Fatehabad Road. At present the dome and a part of Taj Mahal is partially visible from this point. Located 1.08 km south of the site, this point on the Fatehabad provides the first views of Taj Mahal.</p>	<p>1. Proposed Underground Metroline in Taj area do not have any impact of Taj view points as well as visaul relationship of Taj Mahal, Red Fort and Jama Masjid .                  2. It has been observed from the study that the proposed elevated alignment on Fatechbad road do not causes any visual impact on these 16 viewpoints.                  3. An elevated Metro line is proposed over Fatehabad road, is likely improve the visual connections of the visitors which is at present hidden behind modern constructions                  4. The net result will potentially provide the historic building with an improved visual character.</p>

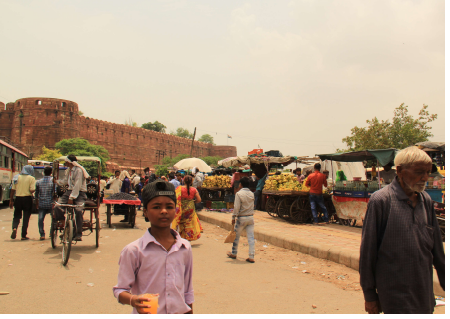
2	Agra Fort

<p>The visual analysis is based on views from external spaces within the public domain and not from inside buildings or private spaces. (View from Red Fort road, looking north of the site) A highly trafficked road, the northern stretch of the Red Fort Road is the portion of the site visibility, this location lies 100m from the site and is a primary entry point for Agra Fort. South wall of the Agra Fort is visible from road along the proposed Metro station of Agra Fort.</p>	<p>1. An underground Metro line is proposed along the stretch of Agra Fort therefore do not impact the existing visual coonectivity.                  2. Underground alignment parallel to the road do not impact the visual connecticity between the two World Heritage Sites                  3. There are two proposed Metro stations in close vicinity to the Agra Fort. After visual analysis it can be concluded that the location of these two stations do not pose any visual obstruction to the monument.</p>

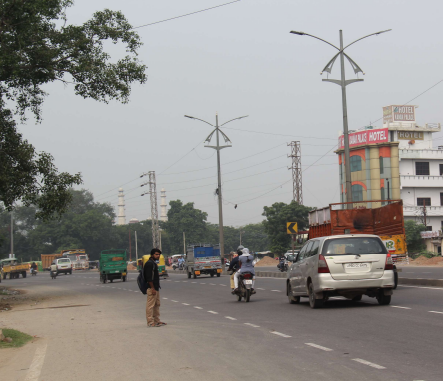
3	Akbar's Tomb, Lodhi tomb and Kanch Mahal Sikandara

<p>(View from the NH19 looking northeast) Located 600 m from the site. This viewpoint is taken from the newly constructed building at the edge of the road, located adjacent to the site without intervening structures or vegetation to mitigate the view, multiple structures of the proposals become visible. The main gate of the complex is visible from NH19 (viewpoint SKV1) along the proposed Metro station of Sikandara. Another viewpoint was identified on NH19, located 700m from the site, from this view point Minarets of the gate are visible.</p>	<p>1. Elevated Metroline on Sikandara road will not have any impact on the visual connectivity.                  2. Elevated Metroline would provide better views of the Akbar's tomb and enhance the visitor's experience                  3. There will be no visual impact on Kanch Mahal                  4. The context of Lodhi tomb would be changed sue to elevated Metro station and Metro line at a distance of 103 meters.</p>

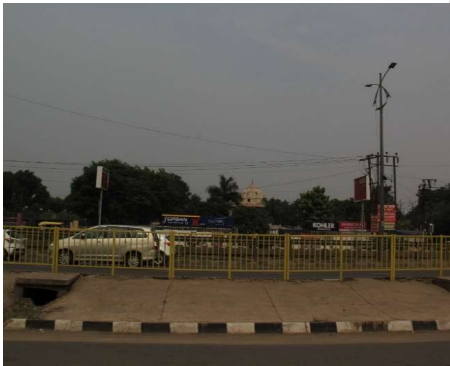
6.2	<b>Tomb of Sadiq Khan</b>

<p>(View from the NH19 looking north of the site) – Located 100m south of the site (view point SQV1), the NH19 is the primary access point in to Sadiq khan tomb for those travelling on the NH19 from the Sikandara. At present, the dome of Tomb of Sadiq Khan is visible from the road. and main entry of the tomb.</p>	
7	<b>Barah Khamba</b>

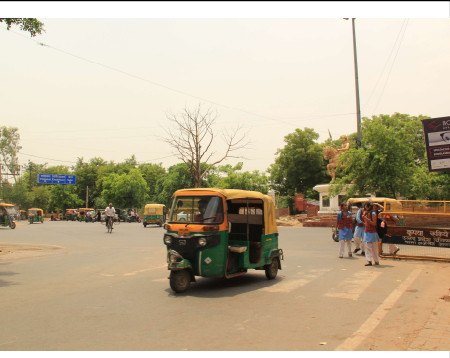
<p>The structure in the the Taj ganj area near the Taj Mahal so the building is cover with residennce and the is vesy dence No any visual connection from the Fatehabad road.</p>	No impact on visual connectivity
8	<b>Old Delhi Gate of City</b>

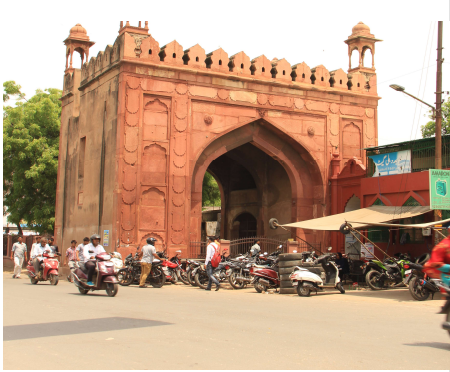
<p>(View from the hariparwat road looking south site of the site) Old Delhi gate viewpoint was identified on hariparwat road. At present the whole structure visible from the Raja ki mandi railway station road.</p>	<p>1.Metro line to be underground this stretch and no visual impact on visual connections and context 2.There are one proposed Metro stations in close vicinity to the Delhi gate. After visual analysis that the location of station do not pose any visual obstruction to the monument.</p>

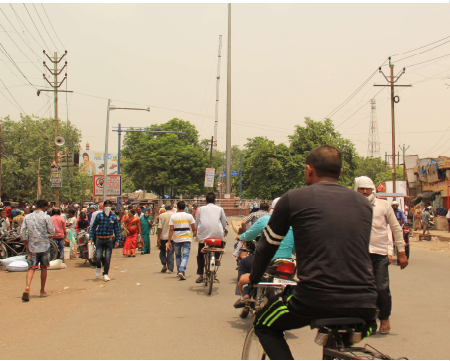
9	<b>Jami Masjid</b>

<p>(View from jama masjid road, looking south of the site).A highly traffic corridor, this portion of the market Road and primary shopping area in town and , At present multiple tall structures obstruct view of Jama Masjid along the proposed route, leaving no clear view points.</p>	<p>The proposed corridor 1 Metro line continues to be underground along this stretch. Therefore, visually there won't be any negative impact of proposed Metro line and station on Jama Masjid.</p>
10	<b>Ladli Begum Ka Tila</b>

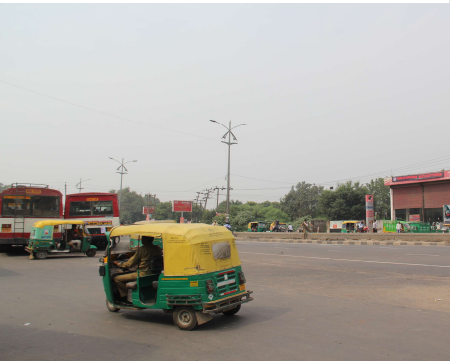
<p>(View from NH19, looking south of the site) No visual connection from road.</p>	<p>No visual impact</p>
11	<b>Shahjahan Park( partially part of Taj buffer)</b>

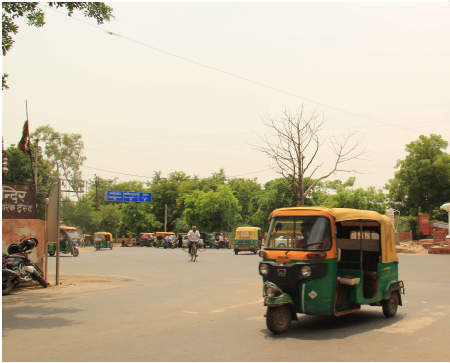
<p>The heritage structures within Shahjahan park are covered with heavy vegetation growth and are thus there are no visual connections from Agra Fatehabad road.. Only we can see the structure opposite of the Metro line from the yamuna kinara road..</p>	<p>1.Proposed underground Metro line along the stretch of Shahjjahan park will have no visual impact on Shahjahan park and its historic strctures 2.Construction of elevated entry and exit points would slightly affect the visal setting .</p>

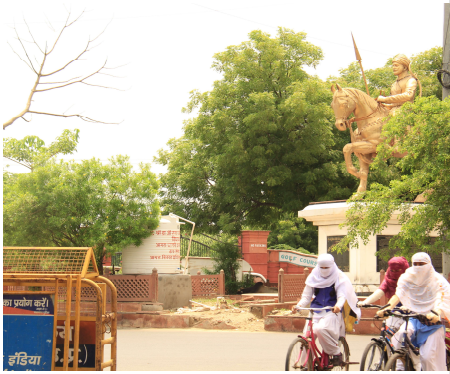
12	<b>Fatehpuri mosque</b>

(View from Fatehabad road, looking south of the site) No visual connection from the fatehabad road.	No visual impact
13	<b>Satti-un-Nissa's Tomb</b>

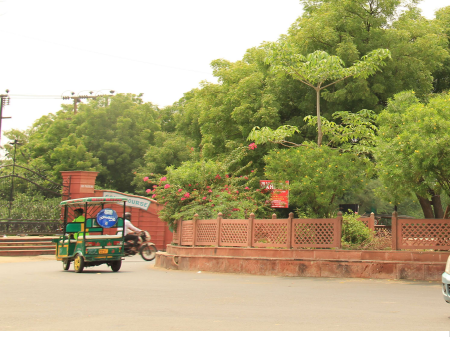
(View from Fatehabad road, looking south of the site) No visual connection from the fatehabad road.	No impact

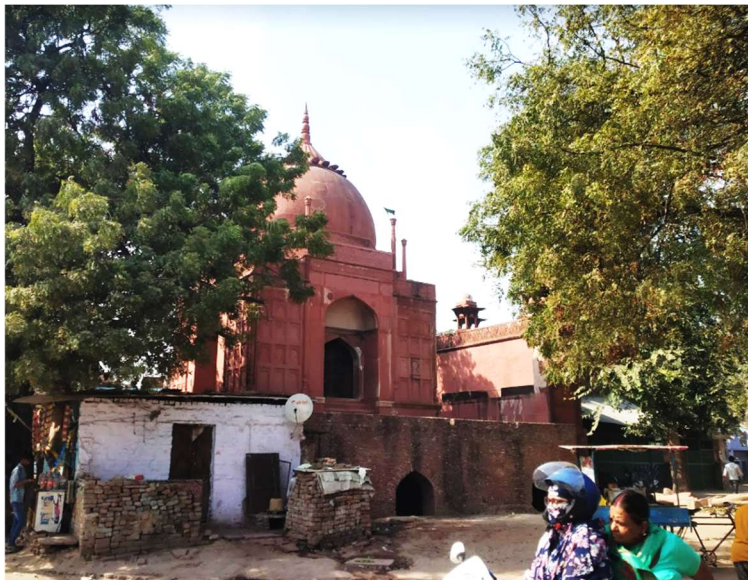
*The tomb view from the road with adjacent shop structure in immediate surrounding*

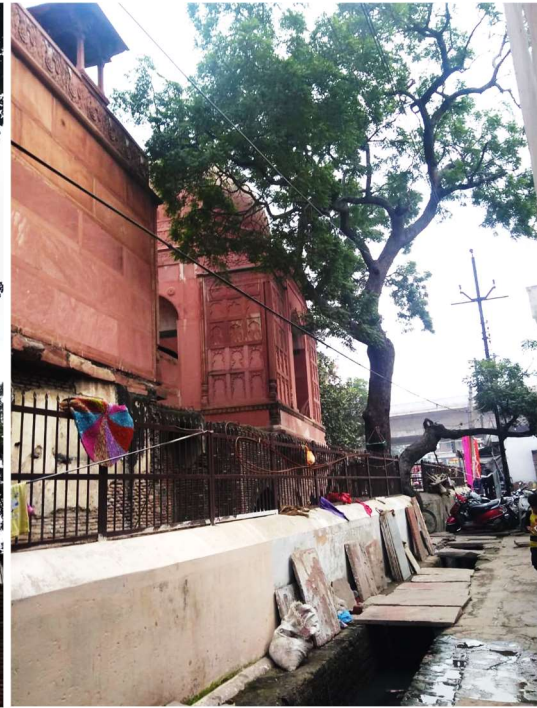
*The rear view of the tomb with drainage nala along boundary wall*

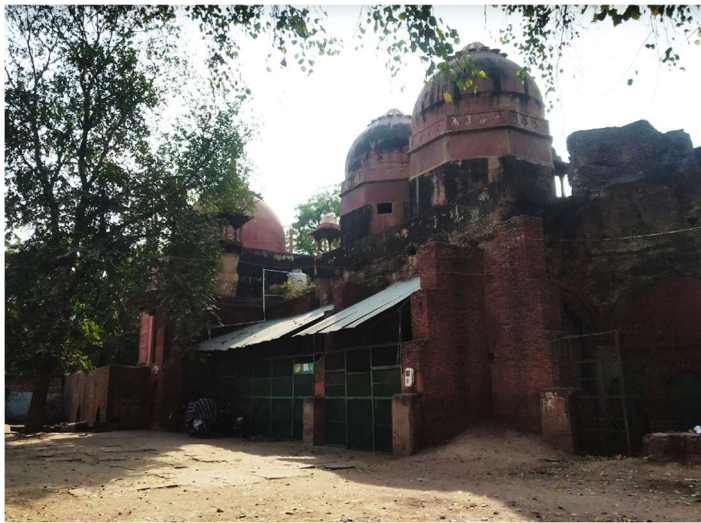
- The immediate surrounding area is encroached.
- The mosque is in use.
- Threat of vandalism
- The mosque is partly collapsed

*The view Shahi Lal mosque from north east direction which got partly collapsed. As the mosque is in use, temporary shed has been added at entry*

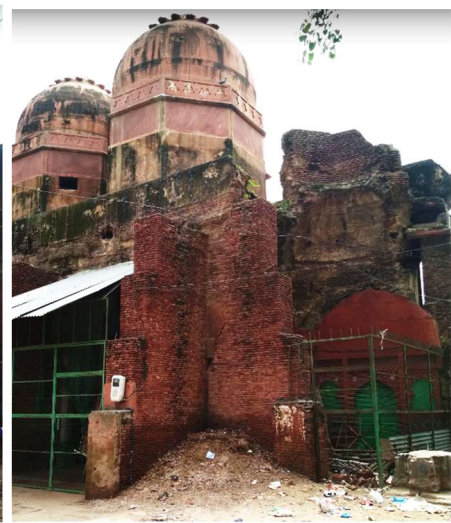
*The image showing collapsed third dome of the mosque and temporary supports of brick masonry.*

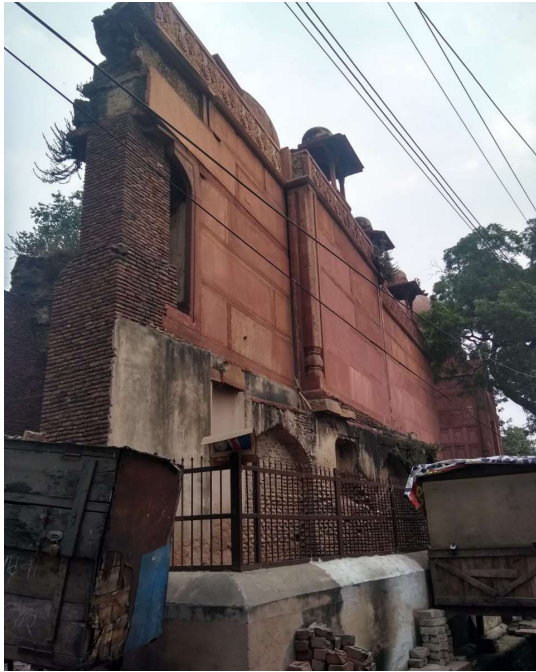
*The view of mosque from north west direction showing a brick masonry supporting the mosque from further collapse*

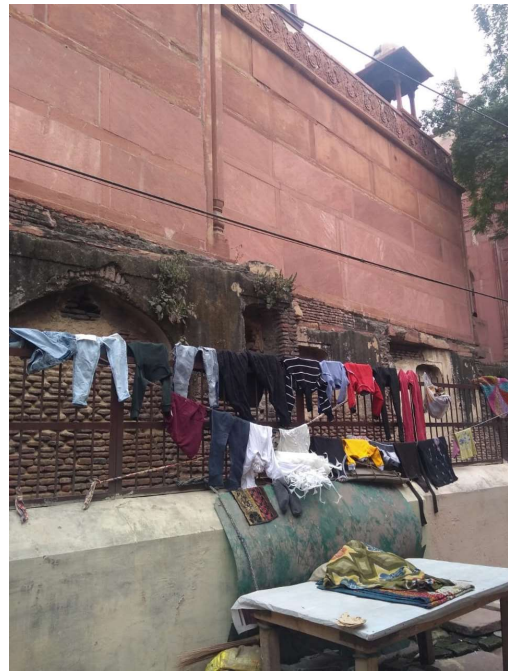
*The rear view of the mosque there used to be a larger platform which does not exist anymore.*

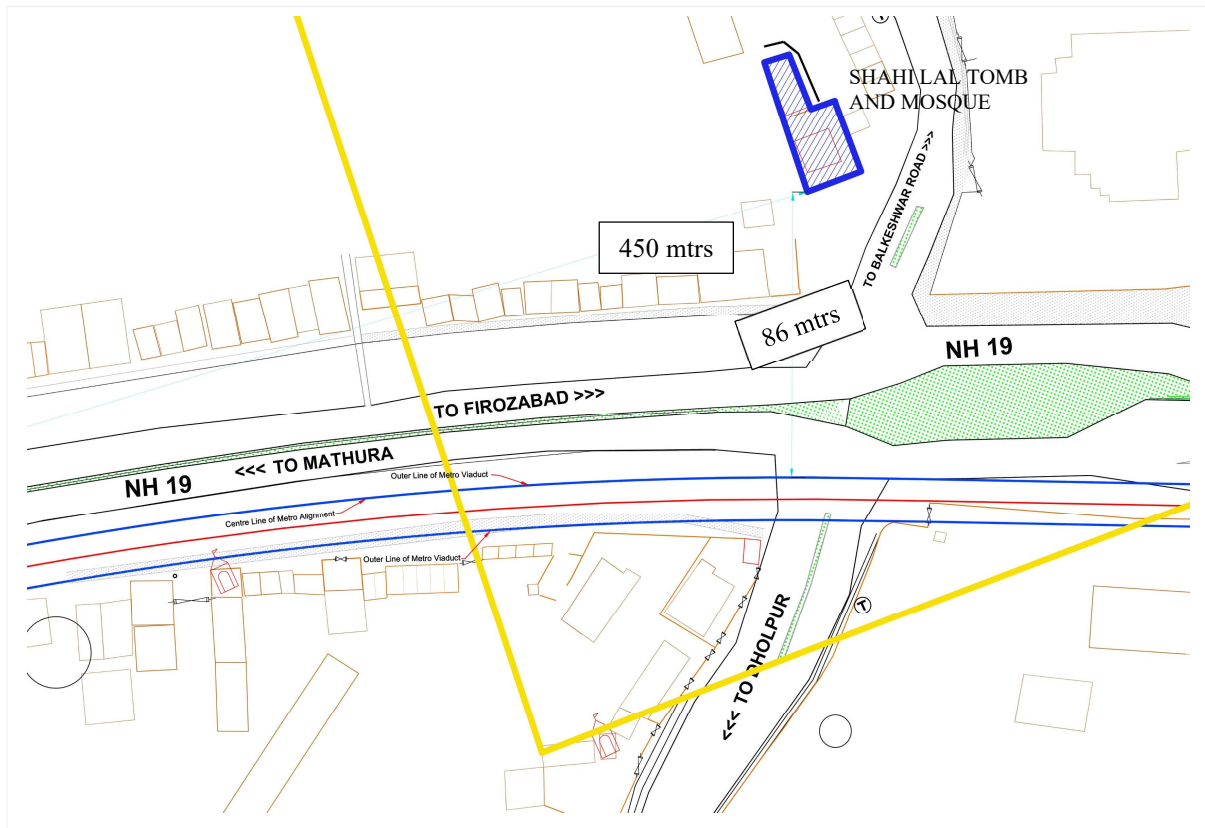
Proposed elevated Metro line is at a distance of 86 mtrs from Lal Masjid and Tomb is within the prohibited boundary of 100 mtrs of Shahi Lal Masjid and Tomb.

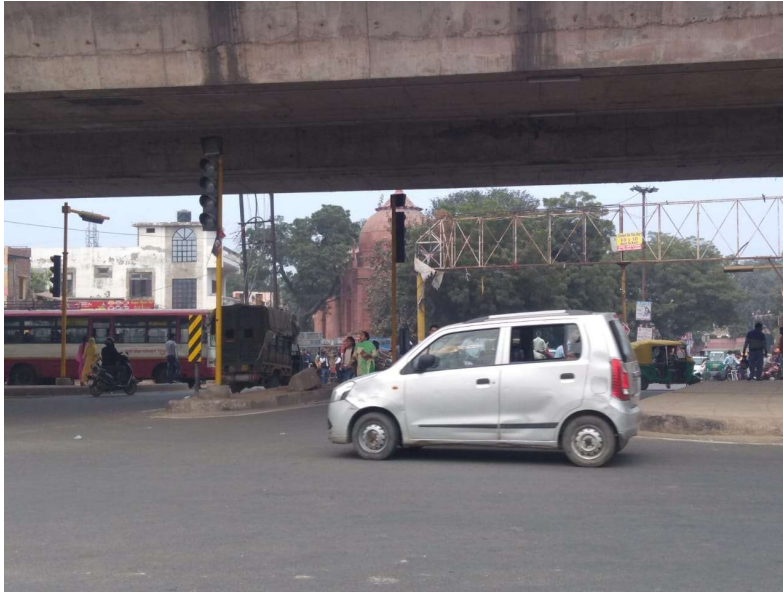
*SHVI View of Shahi Lal Masjid and Tomb from the nursery across the road*

Presently the flyover on National Highway 19 and other street infrastructure blocks the view from the proposed location of metro line. The building structure is partially visible as of now.

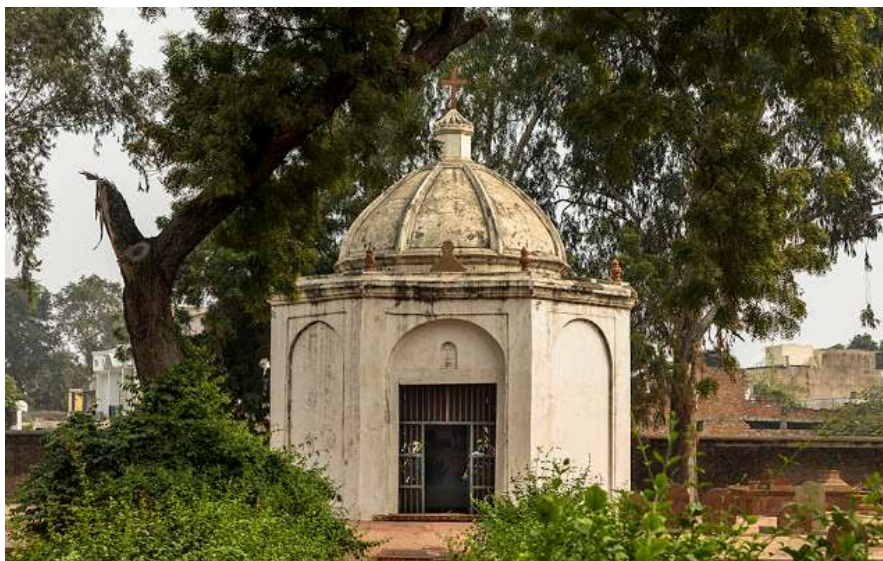
## 1. Marty's Chapel

*The view of Marty Chapel in cemetery complex*

Marty's Chapel is the oldest structure inside this cemetery. It gets its name from Khoja Mortinepus, an Armenian merchant who was buried here in 1611 AD. The octagonal, domed monument has an arched entrance and jaali screens on two sides. The structure is maintained by visitors who light candles and incense sticks and leave flowers on the tombstones. The structure is structurally stable and safe. There is algae deposits on the exterior wall and dome surface. Overall condition of the monument is good.

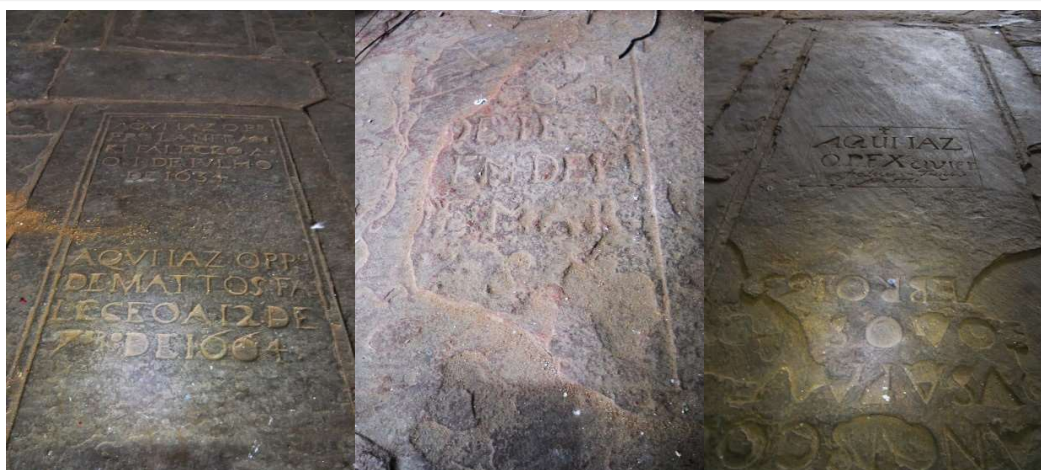
There are many inscriptions in Portuguese inside the chapel. Many on these have which have partially vanquished.

*Portuguese inscriptions inside the chapel*

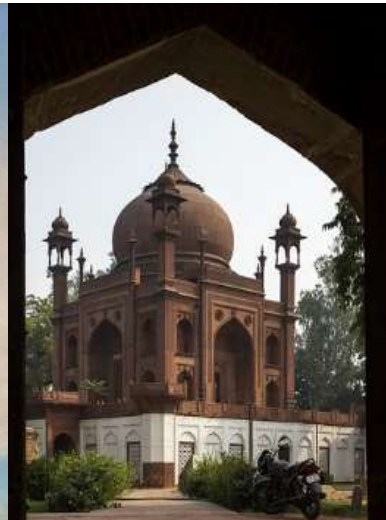
*View of tomb from the entry gateway*

This Red Taj is well maintained and in stable condition. The Hessing's family still visits the structure.

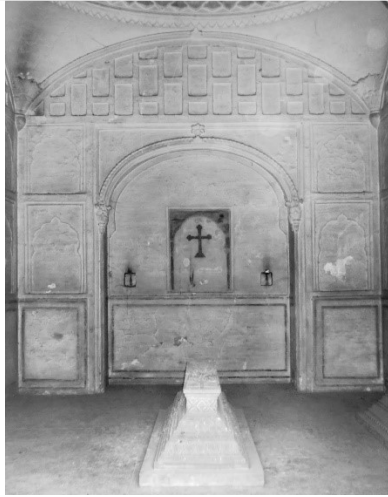
*Interior view of Samru Tomb*

The interior wall plaster is deteriorated and there are plaster cracks on exterior surfaces. The tomb and original gravestone are in good condition.

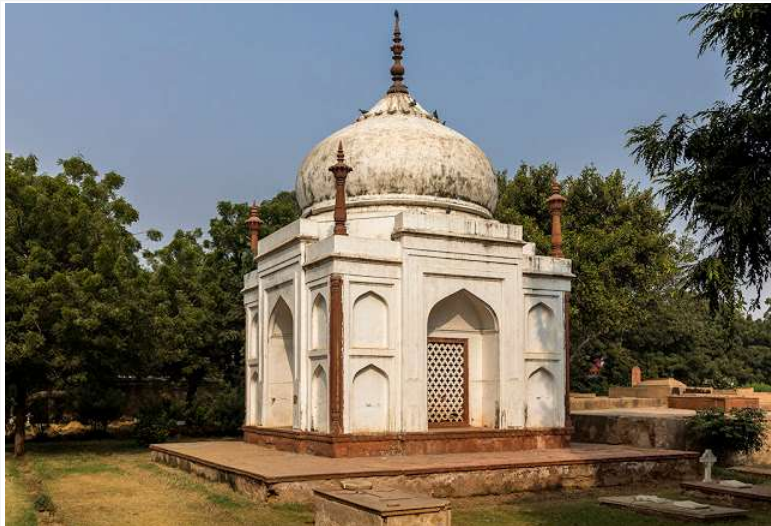
### **5. Unknown Tomb**

The square tomb with bulbous dome is unknown tomb of some Englishman. The tomb is in stable condition. Only the stones plinth of the tomb is deterioration. There is blackening on wall exterior plaster surfaces.

*Unknown square tomb structure*

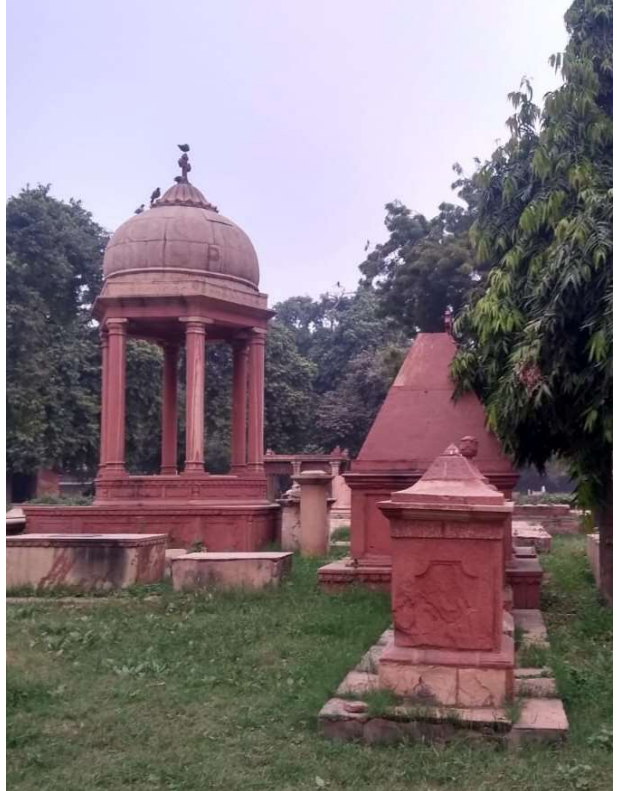
*Other small tombs are in stable condition*

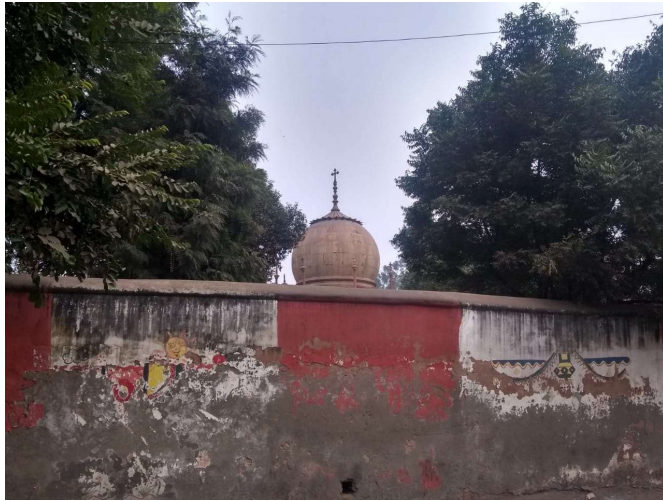
*View of RC Cemetery from MG Road*

The entire cemetery complex is bounded by high walls. Therefore, most of the smaller tombs and gravestones are not visible from either the MG Road or National Highway-19.

The Bagwan Talkies in the north restricts the view from the north direction. Only the domes of Red Taj and Elis tomb are visible from MG Road. No major viewpoint of the complex from the outside as of present

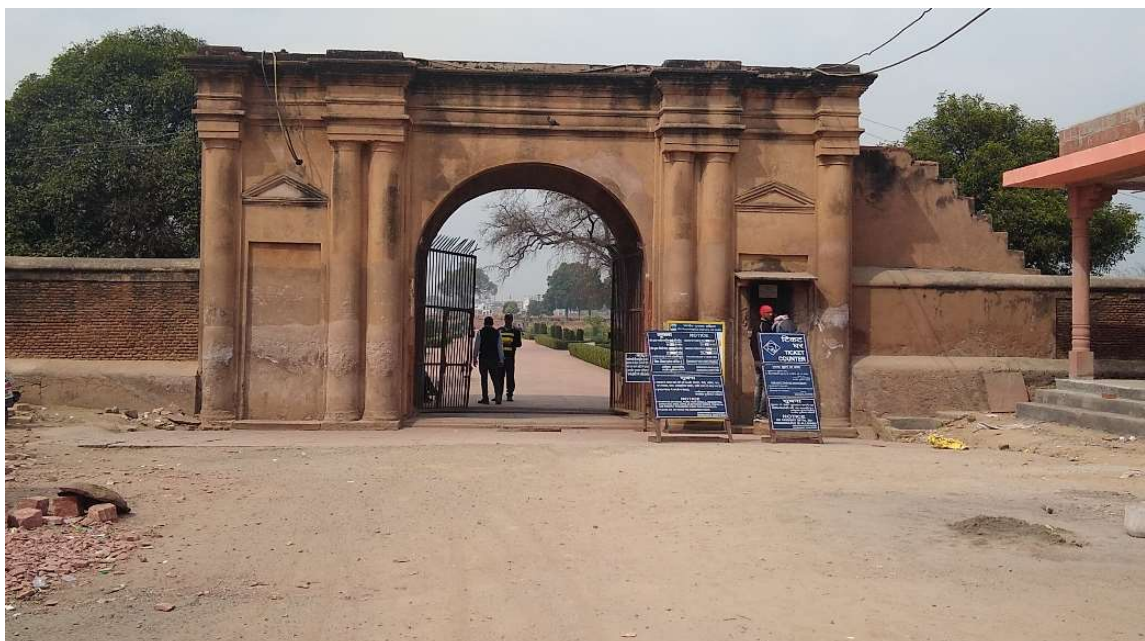
*A colonial gateway to Rambagh complex*

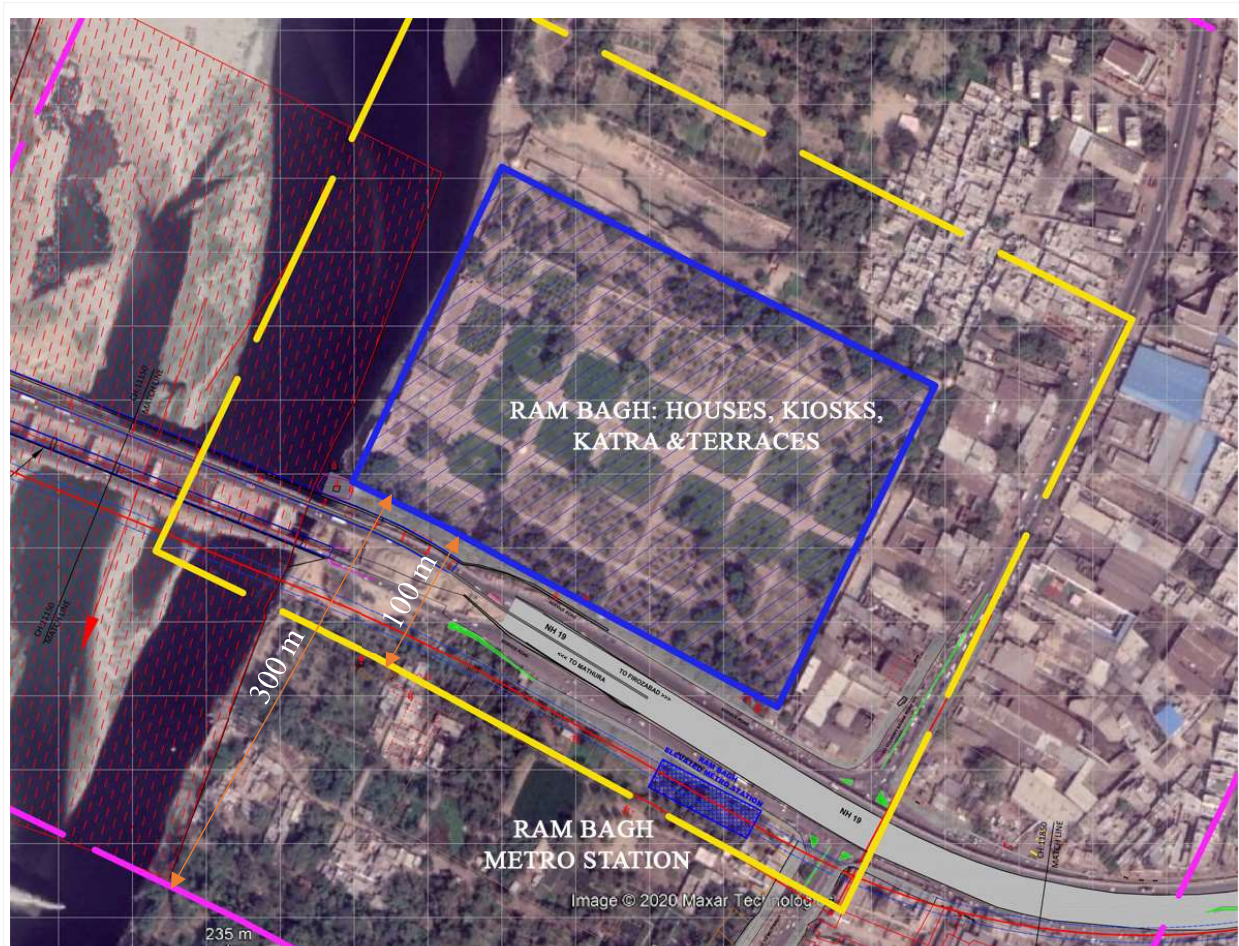
*Protected, prohibited and regulated boundaries of Rambagh Complex*

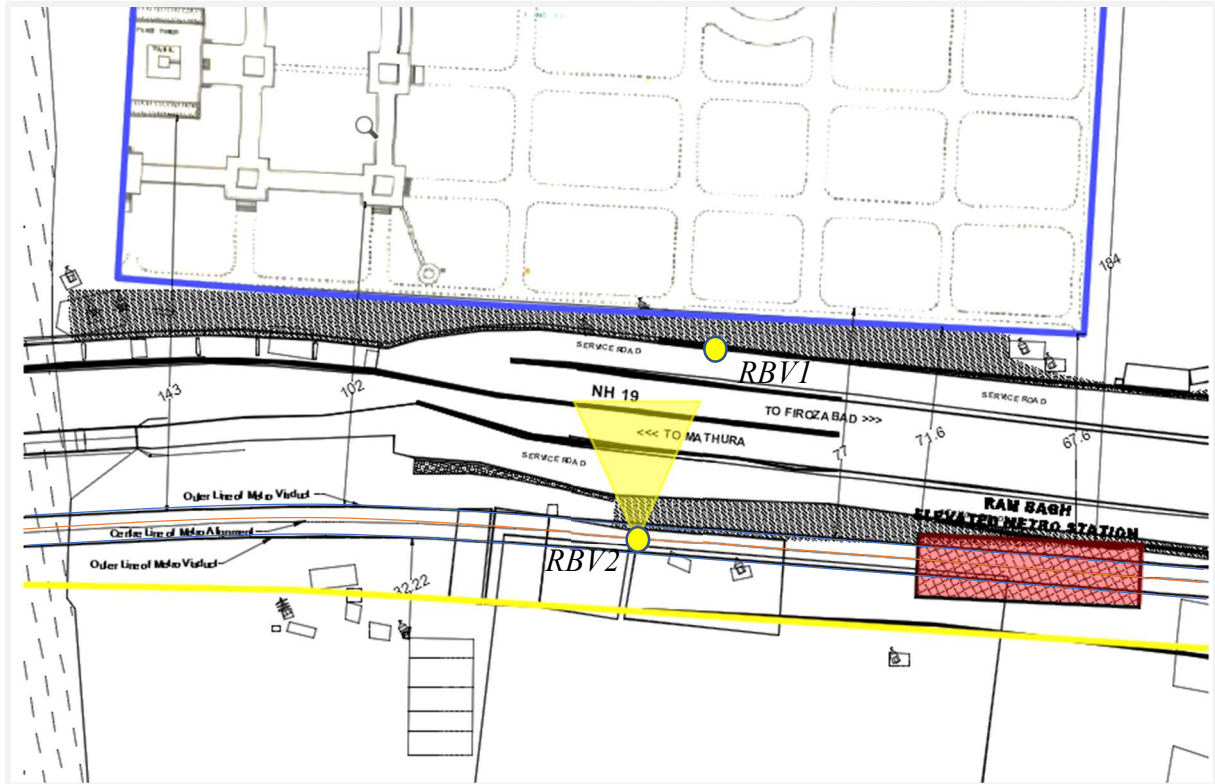
*Image showing the nearest distances to structures inside the Ram Bagh Complex*

No.	Structure	Sub- Structure	Protection Status	Distance from Metro station (m)	Distance from Metro line (m)
1	Ram Bagh		ASI	67	67

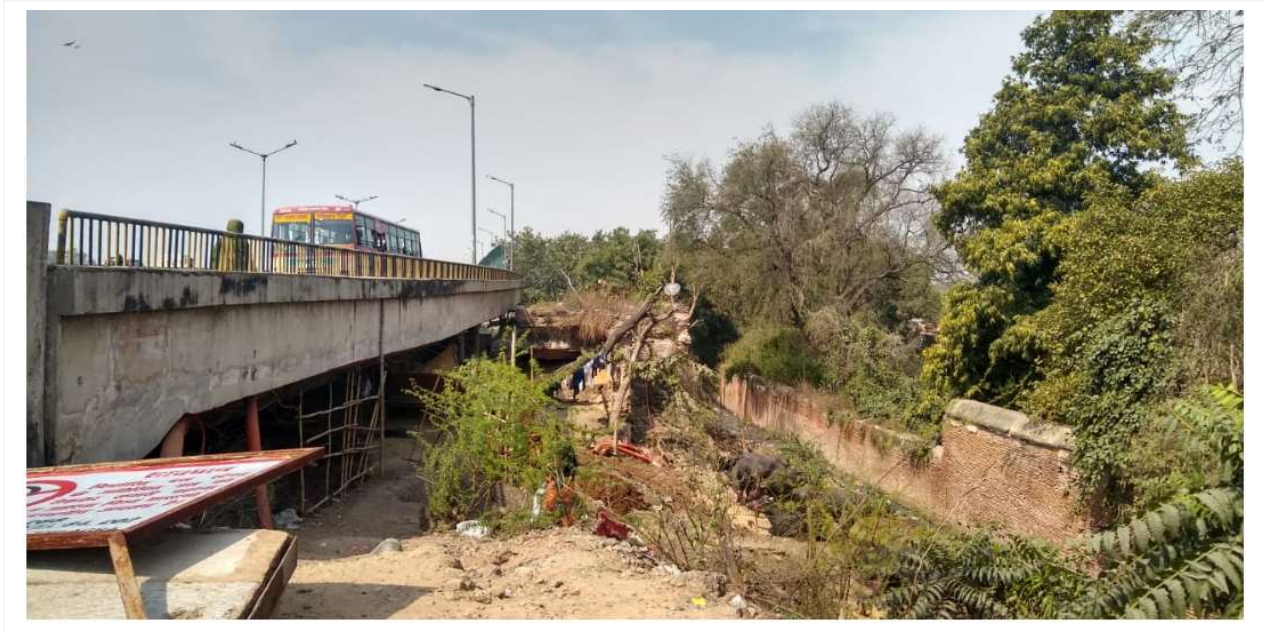
*RBV1 View of Ram bagh complex boundary wall from the edge of highway*

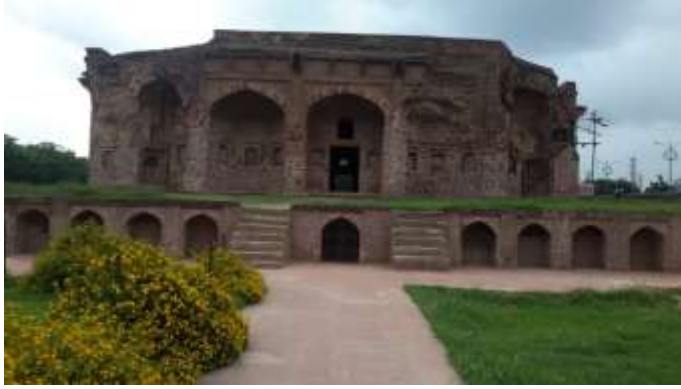
**Figure 24: Lodhi's Tomb**

Cracks were observed in the entrance archway, columns and beams around the central dome. In addition to Cracks, blackening, delamination and loss of plaster was observed.

Cracks were observed to running from the columns in the first floor to the columns in the ground floor, which could be signs of structural distress.

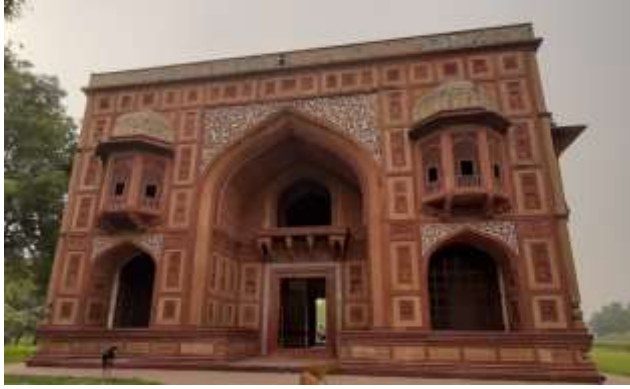
**Figure 29:Kanch Mahal**

Cracks were observed in the columns and beams. In addition to Cracks, blackening, delamination and loss of plaster was observed.

No structural distress was observed in the structural system.

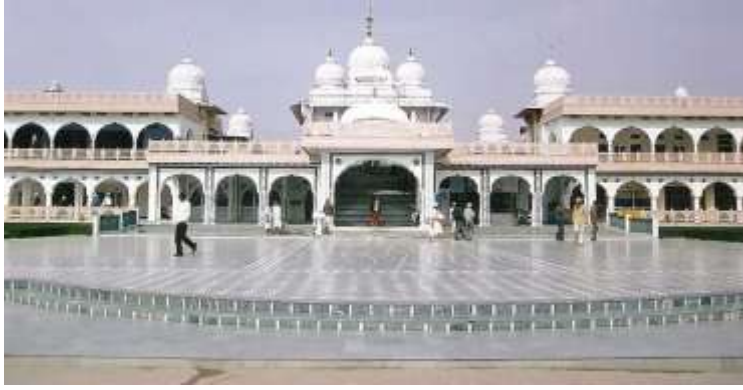
**Figure 34: Guru Ka Taal**

No structural distress was observed but other defects such as blackening and plaster damage was observed.

No structural distress was observed.

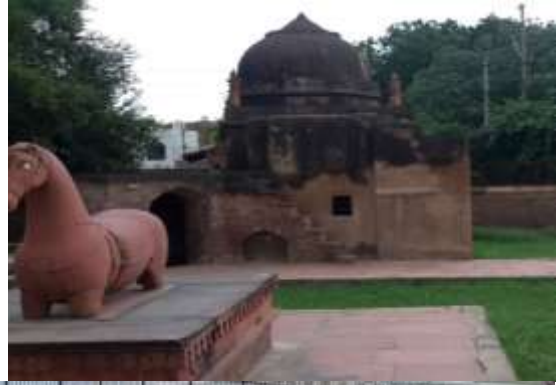
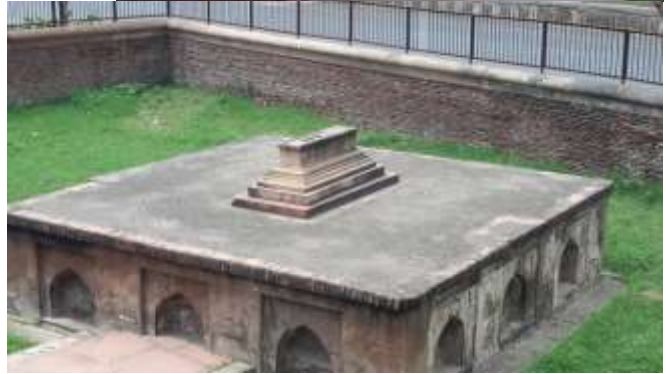
**Figure 40: Pathar ka Ghoda**

Cracks were observed on the dome interiors and the columns has been subjected to wind erosion in various locations

Cracks were observed to running from the domes to the arches, which could be a sign of structural distress.

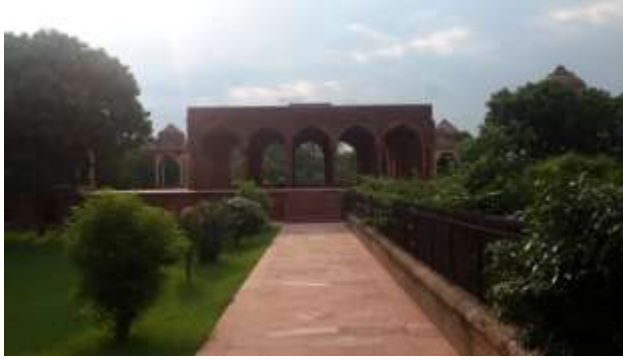
**Figure 43: Tomb of Salamat Khan**

Cracks were observed on the dome interiors and in the entry archways which might be plaster cracks.

No structural distress was observed.

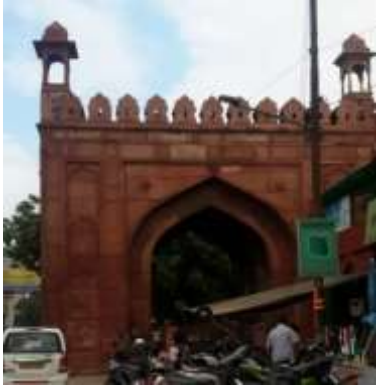
**Figure 54: Old Delhi Gate**

Cracks were observed on the dome interiors and in the entry archways which might be plaster cracks.

No structural distress was observed.

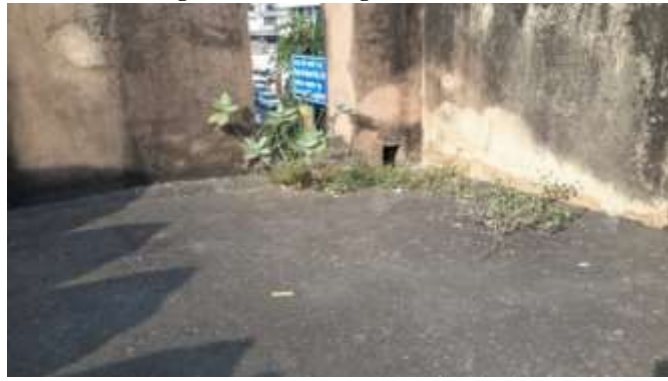
**Figure 58: Vegetation Growth**

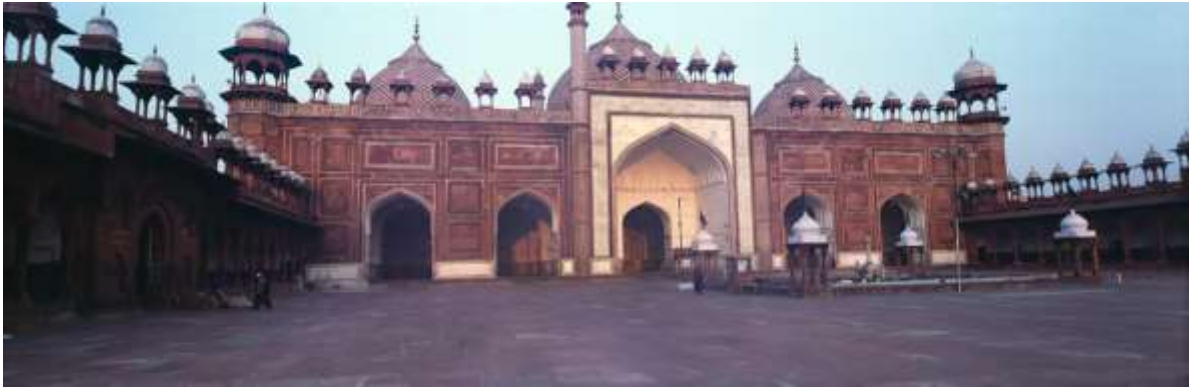
**Figure 59: Jama masjid**

No structural distress was observed in the structural members but other defects such as blackening, fine cracks, vegetation, delamination and dampness was observed.

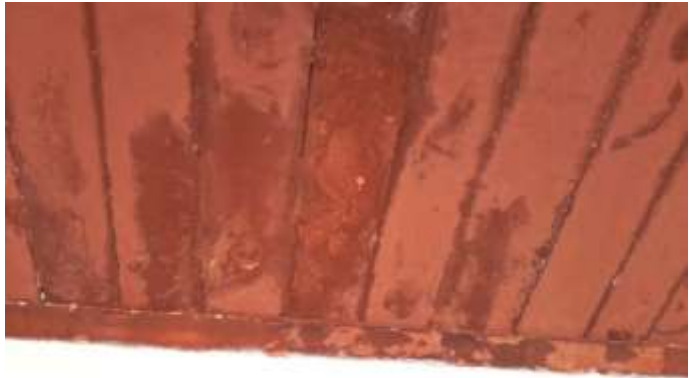
**Figure 62: Water Ingress in roof**

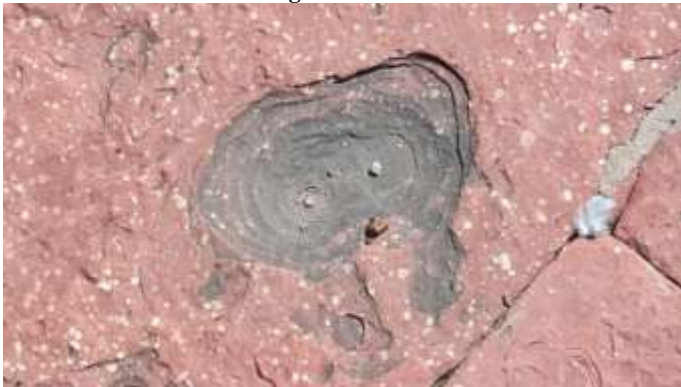
**Figure 63: Contouring in stone**
